## Condition of roads after flooding using the example of the rehabilitation of a communal road

Unterreichenbach

August 2020

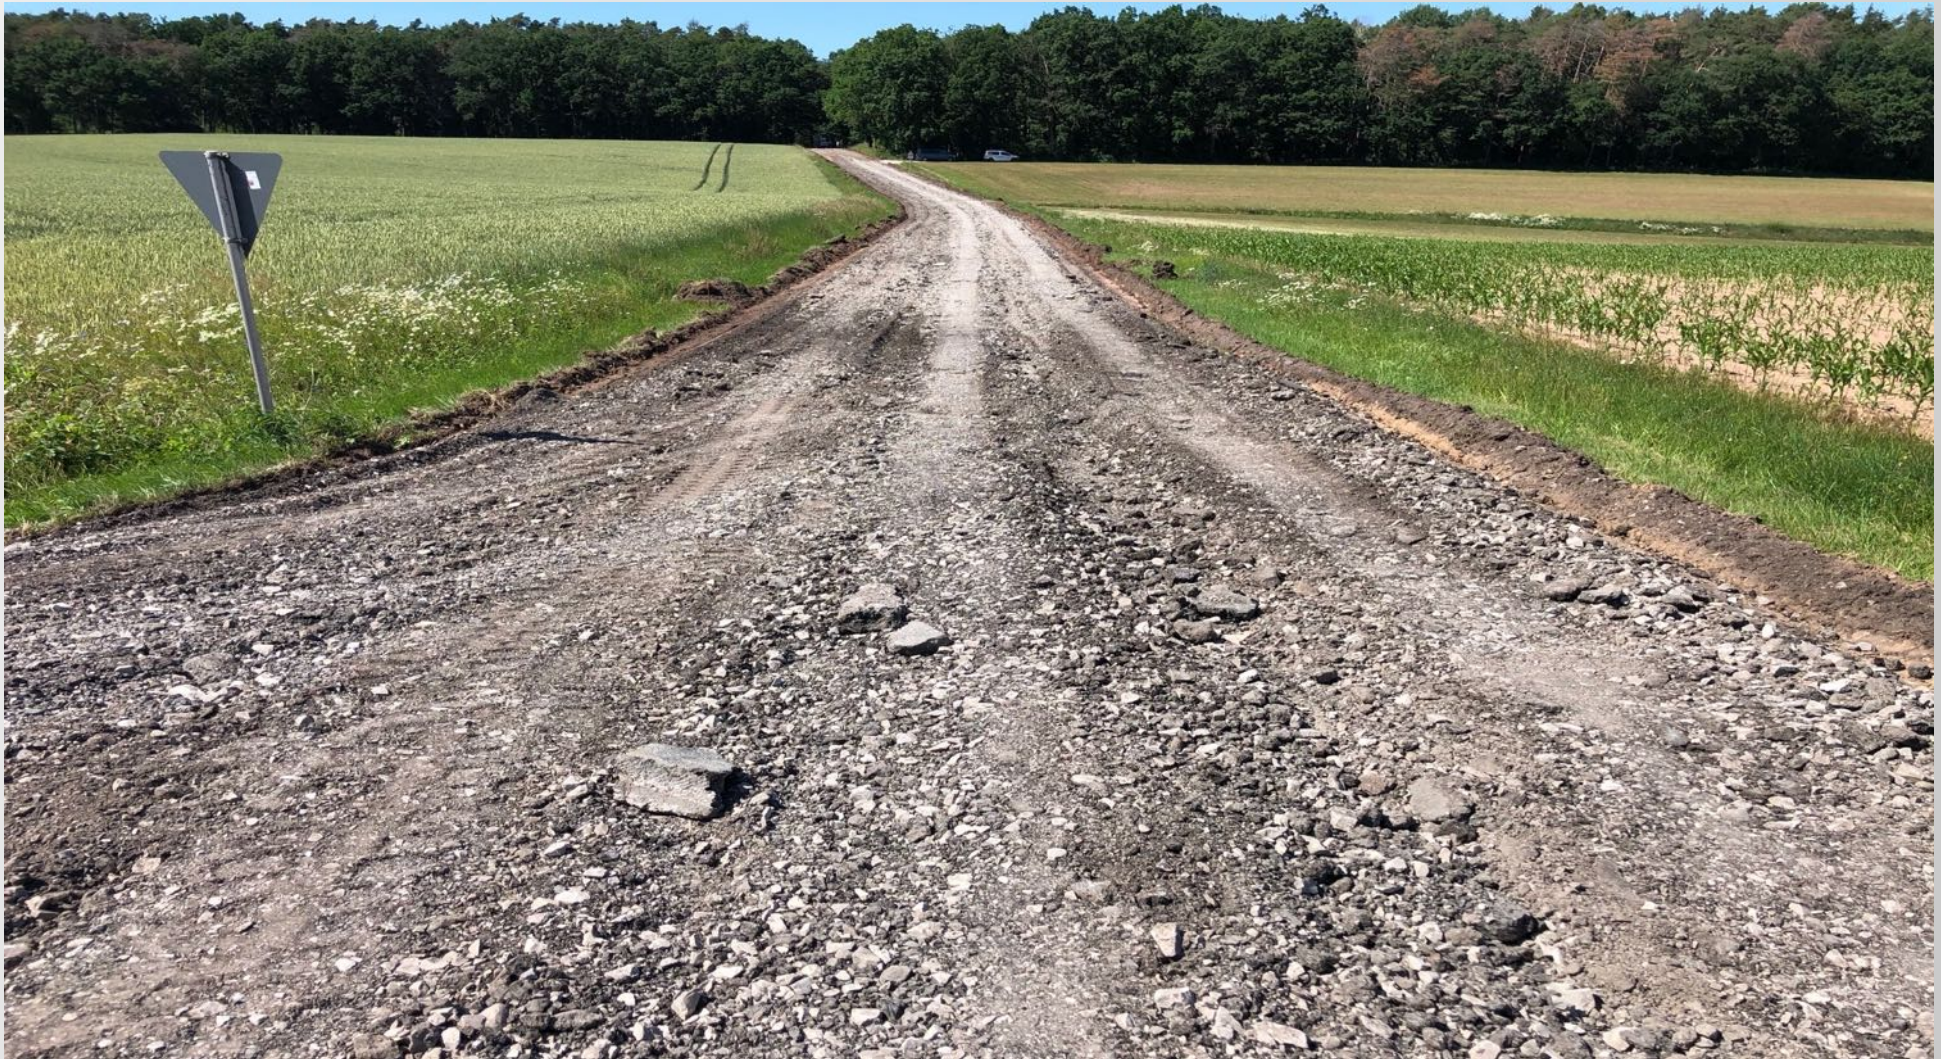
**Initial situation after milling**

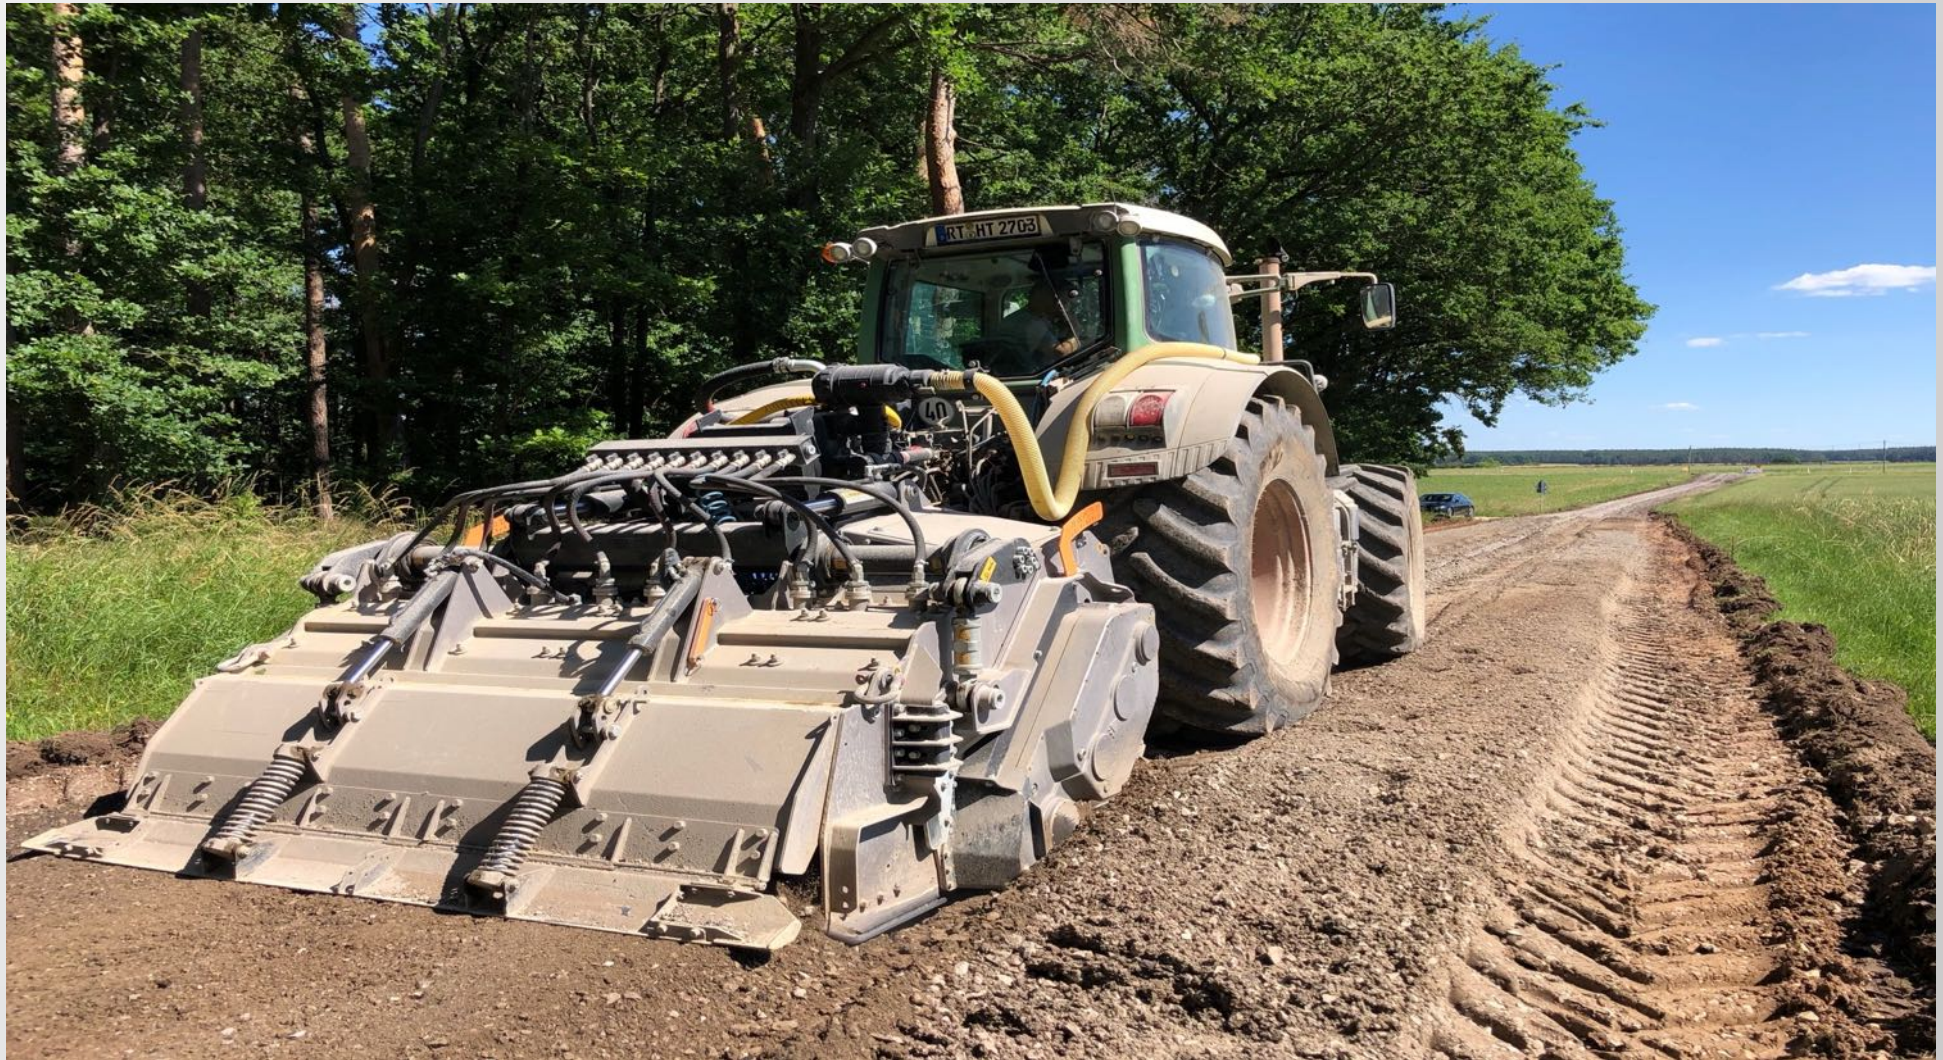
**Use of a stone crusher to crush the raw material to a grain size of 0/32 mm**

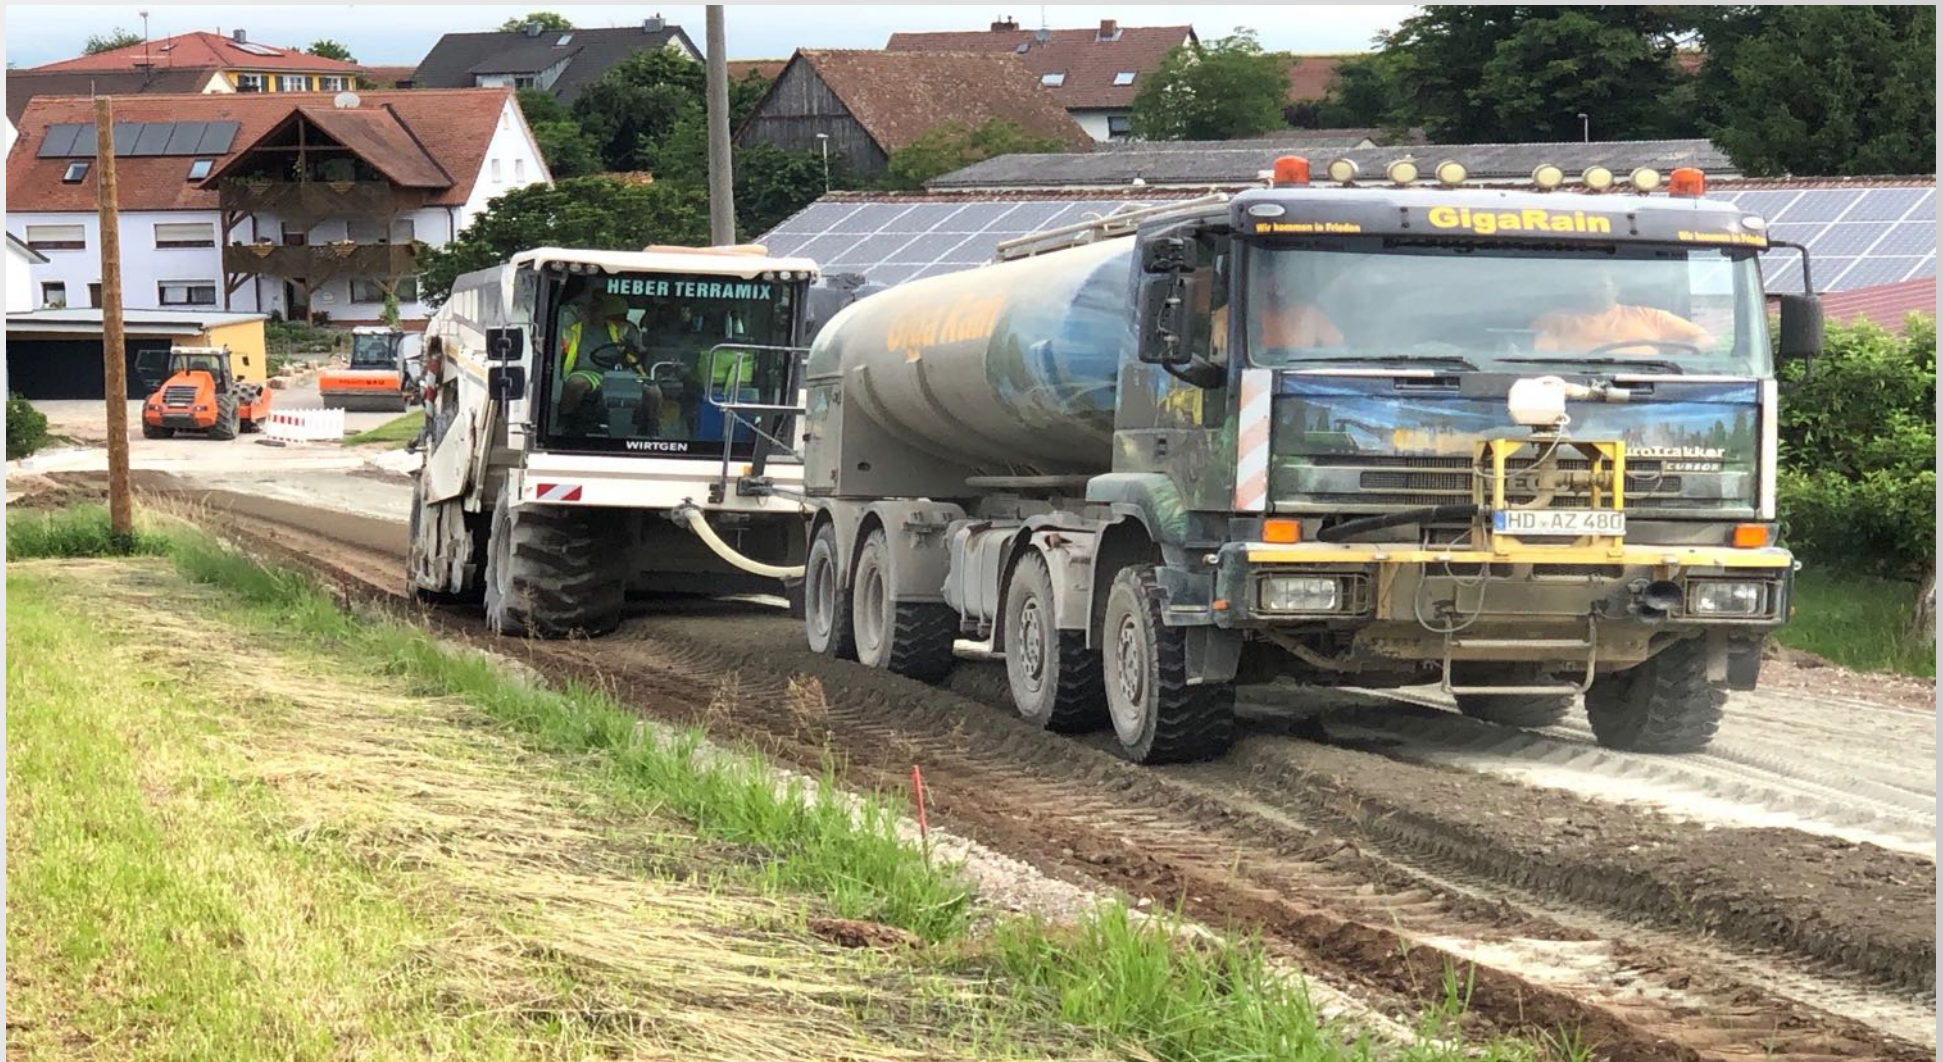
**Milling of the already spread NovoCrete® ST 98 with computer-controlled addition of water**

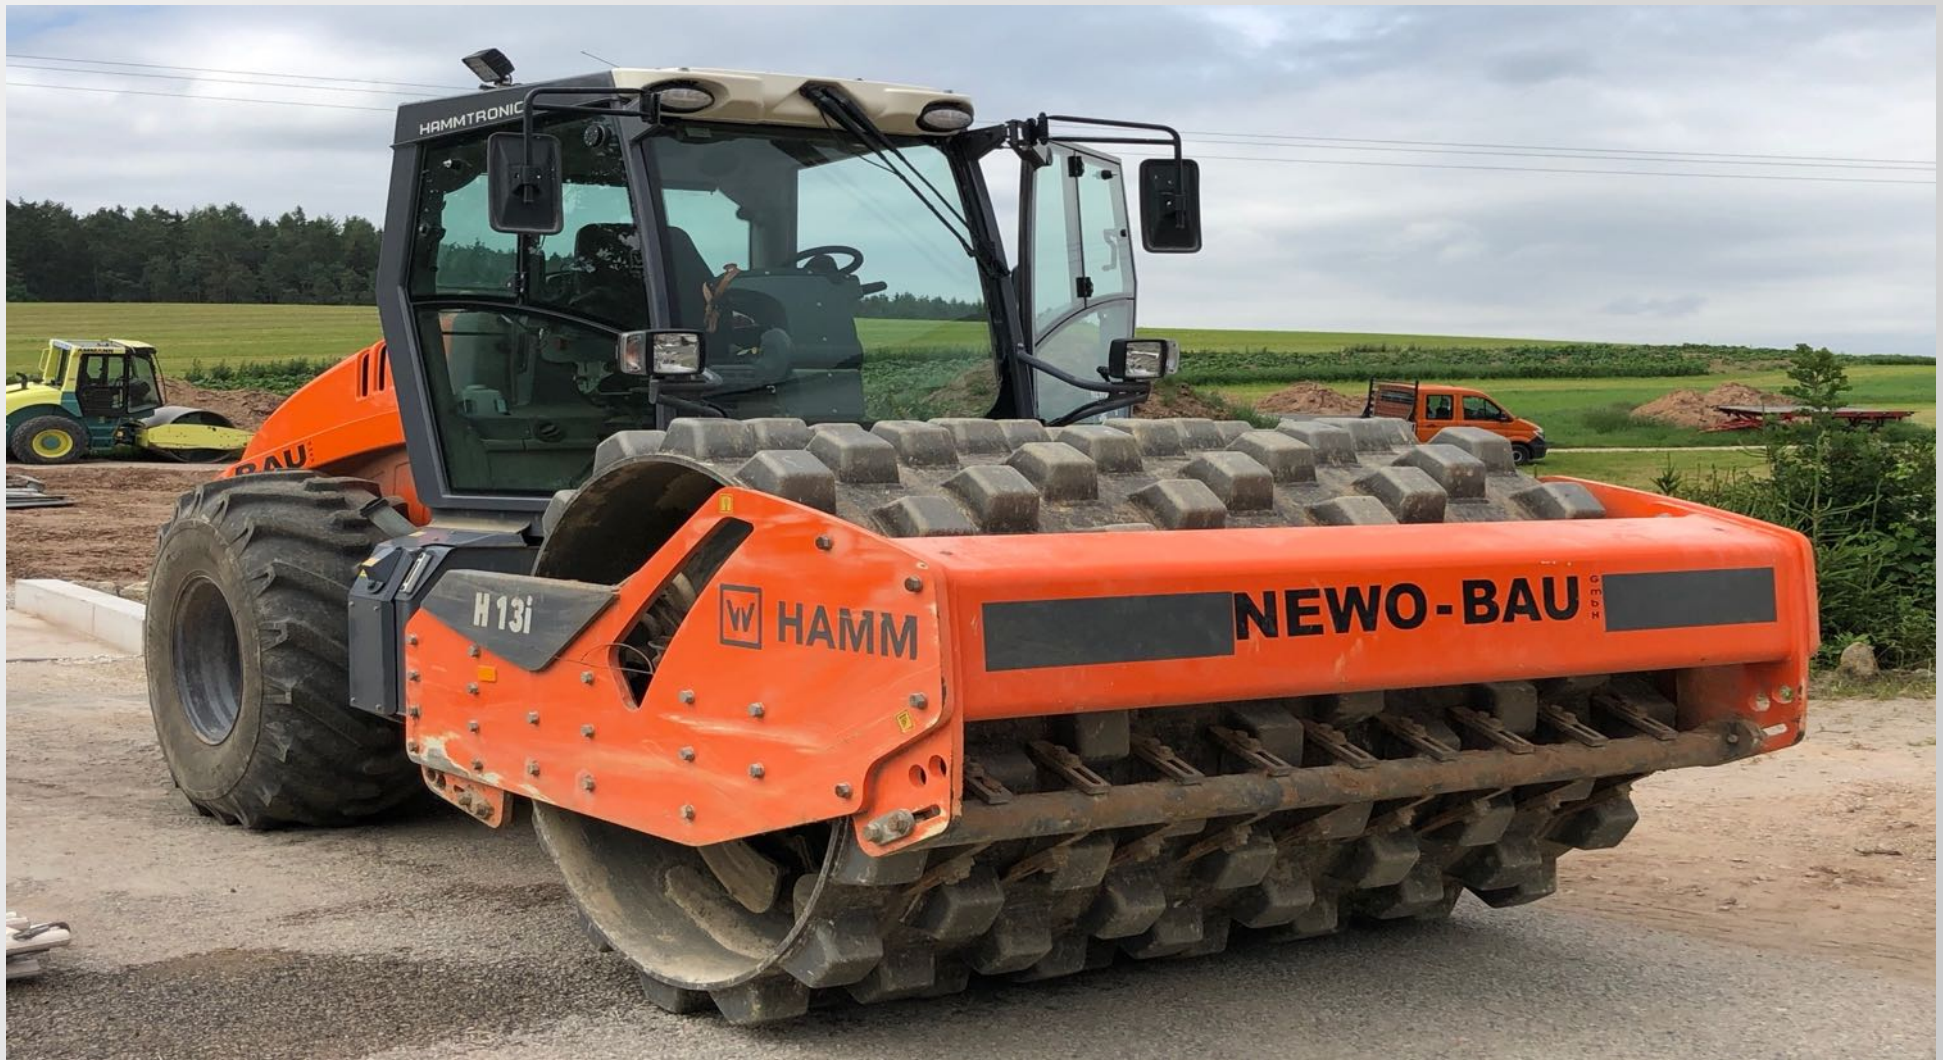
**Use of sheepfoot roller to achieve the best deep compaction**

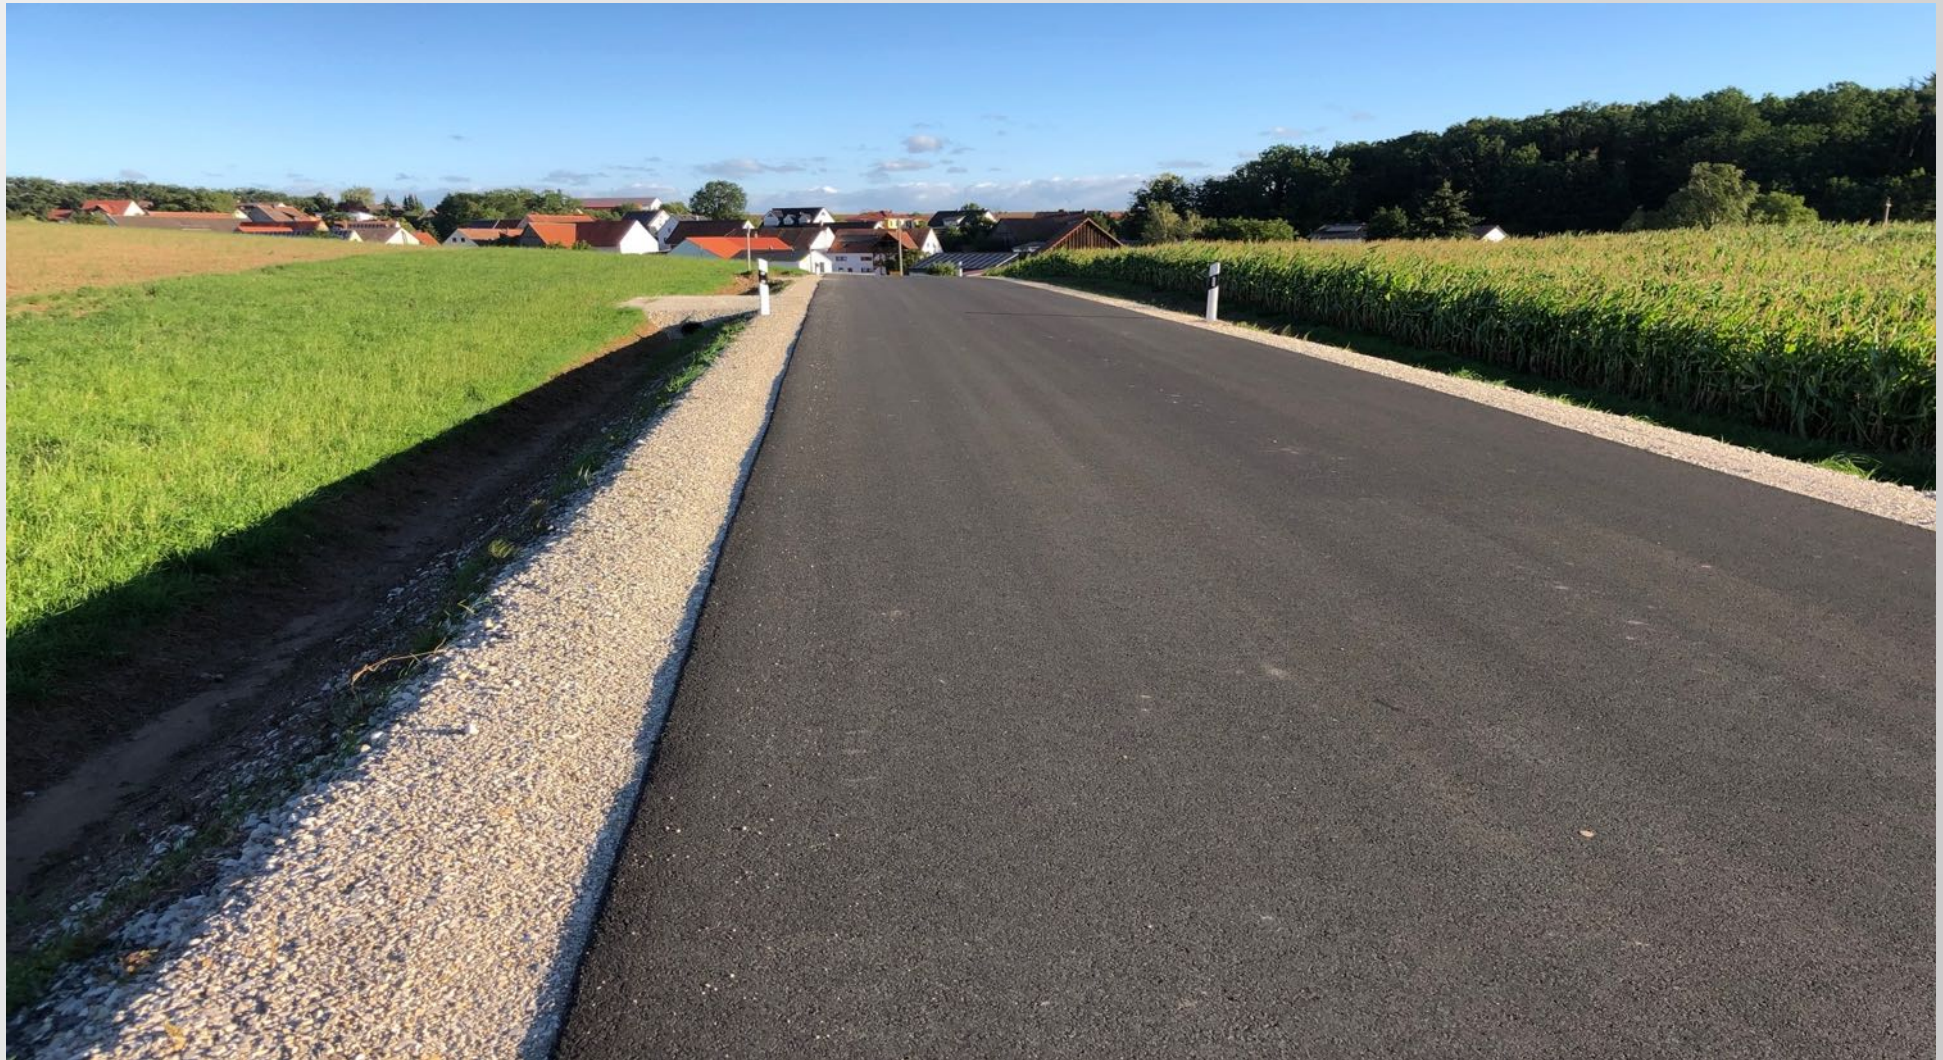
**Completed road including built-in asphalt layer in August 2020**

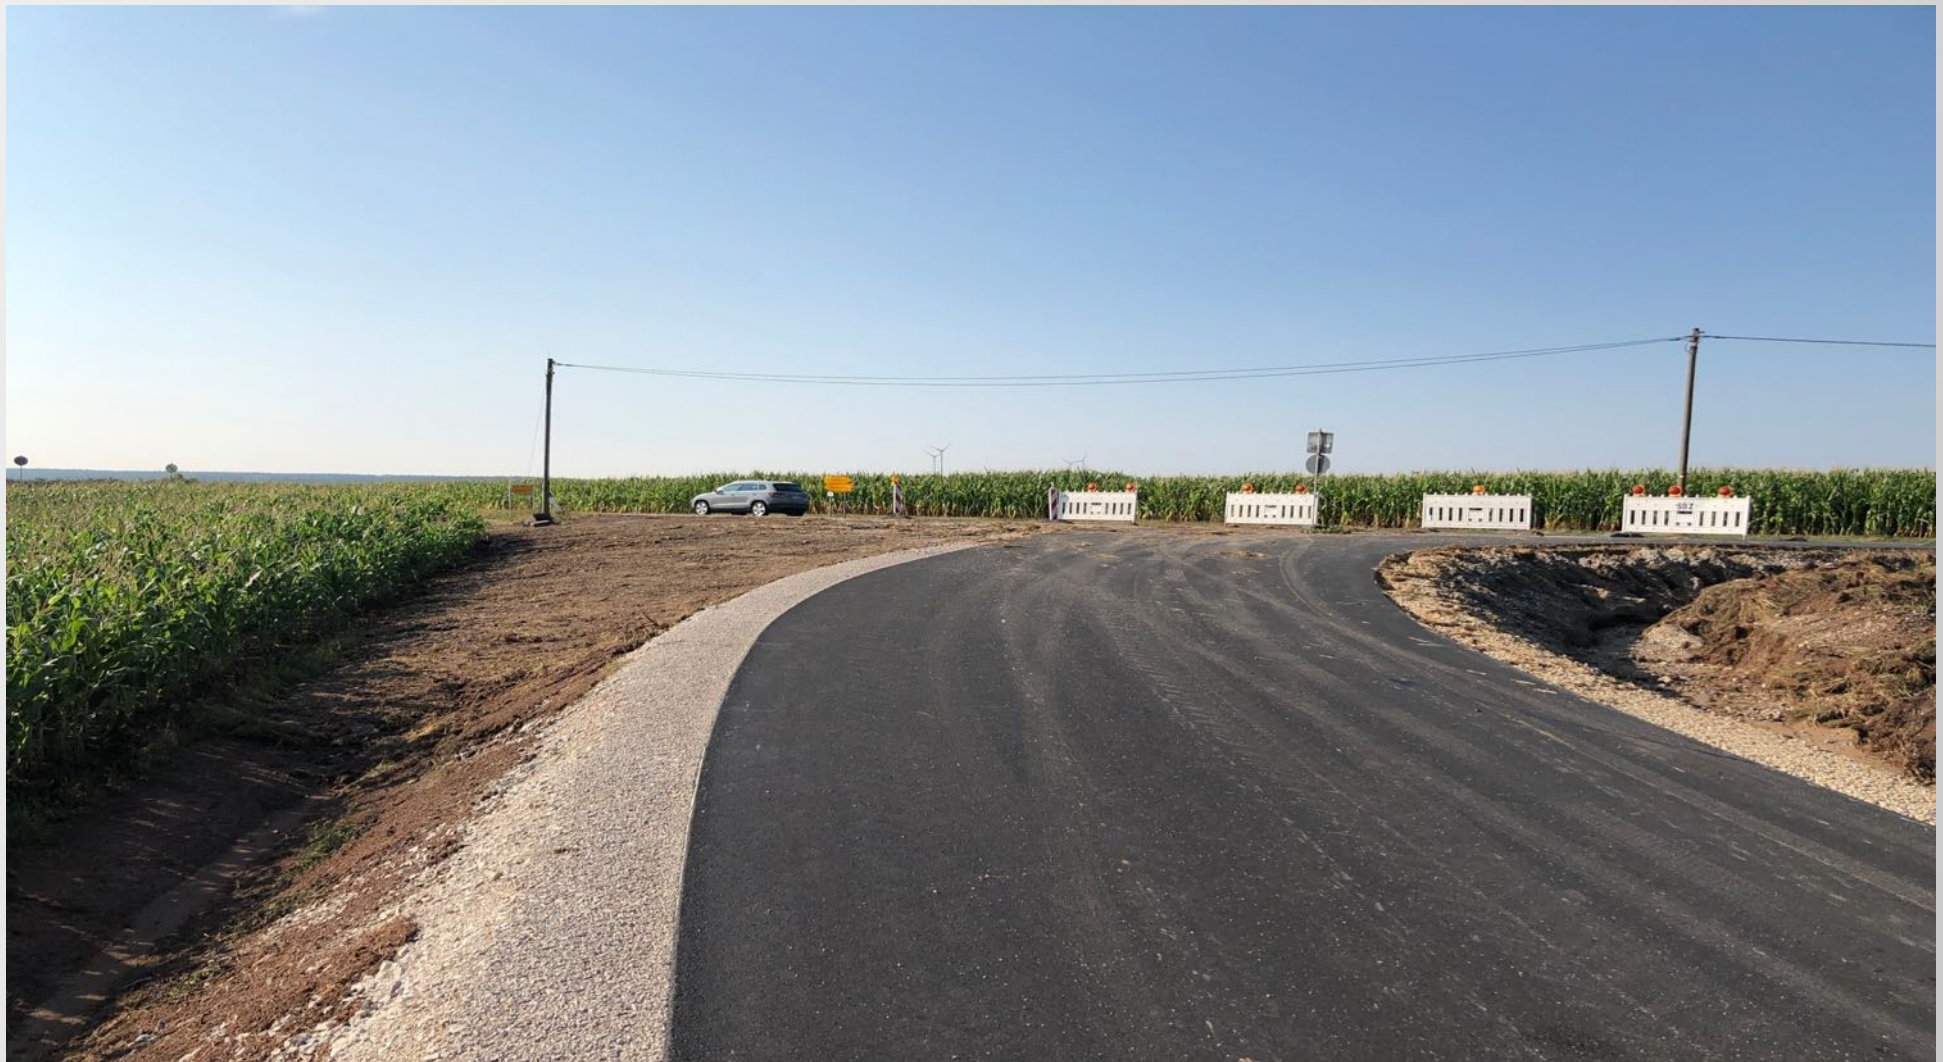
**Condition of the road after flooding due to heavy rain in August 2021**

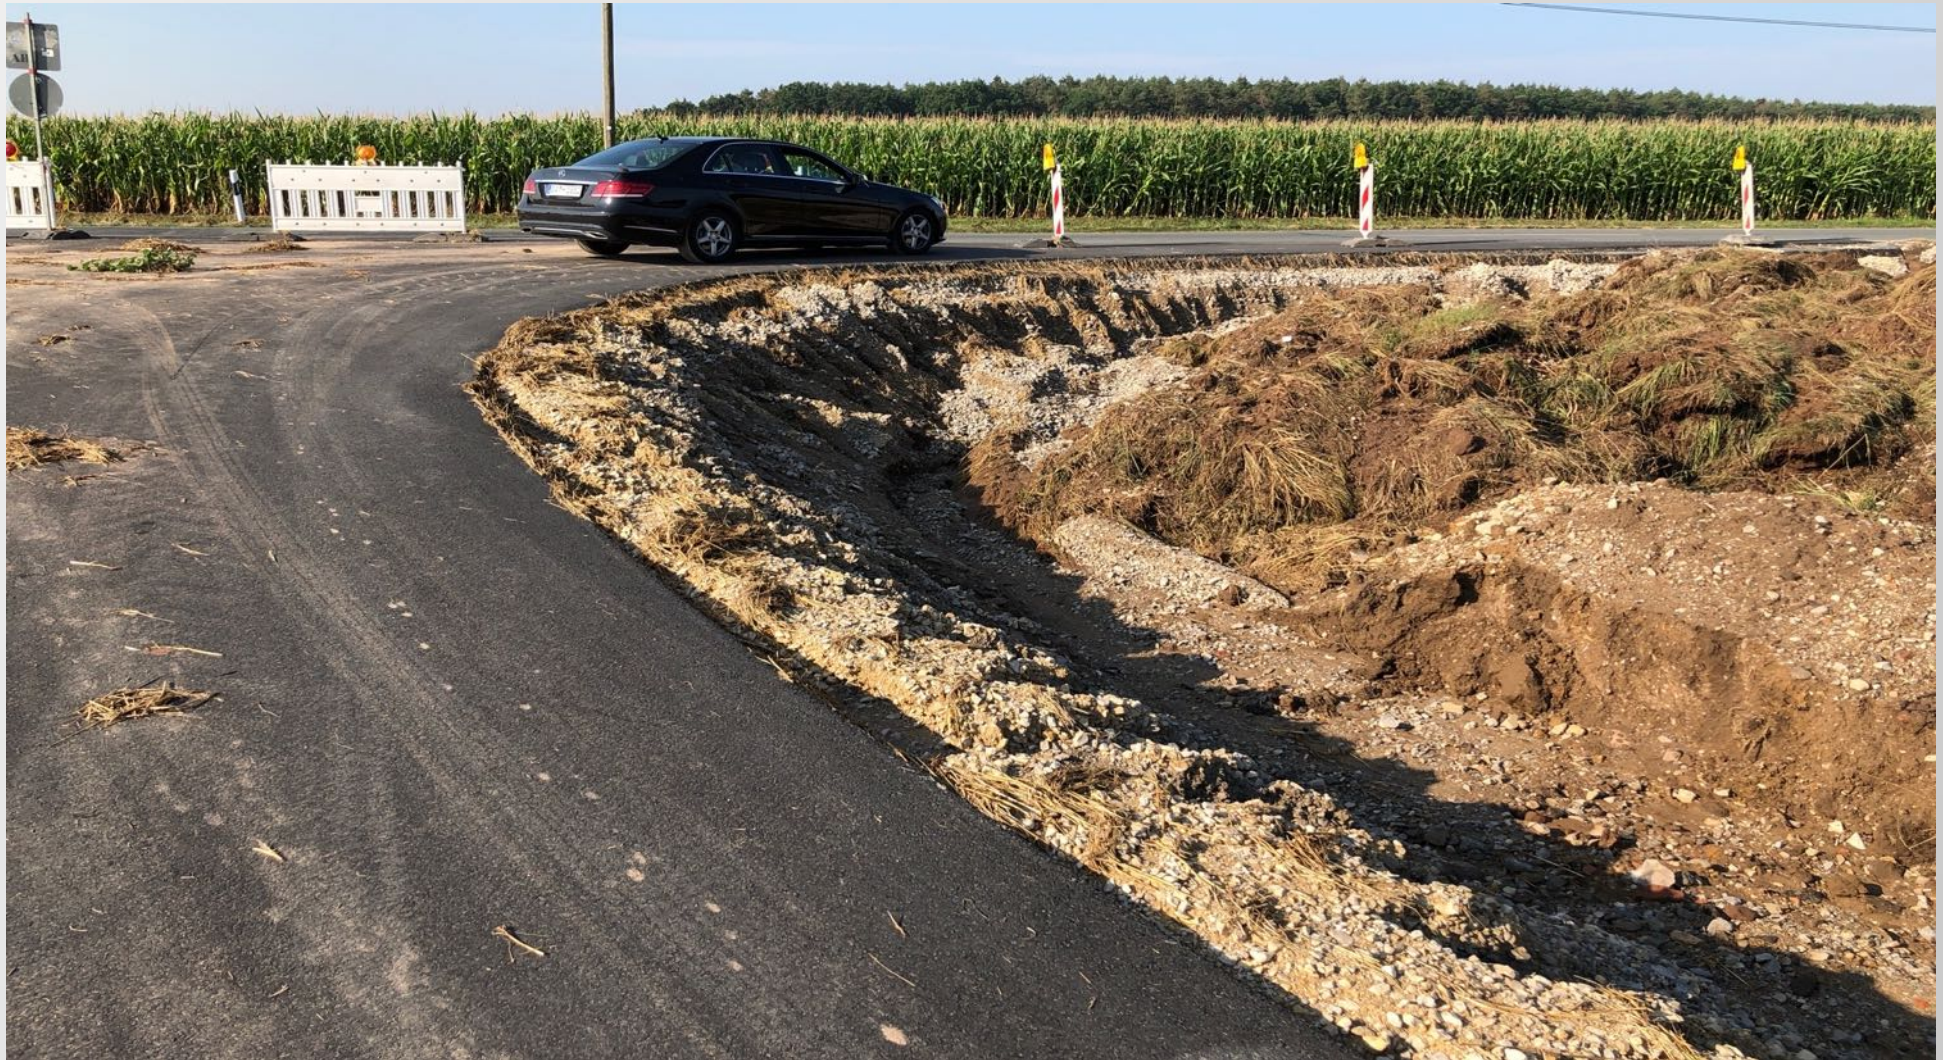
**Condition of the road after flooding due to heavy rain in August 2021**

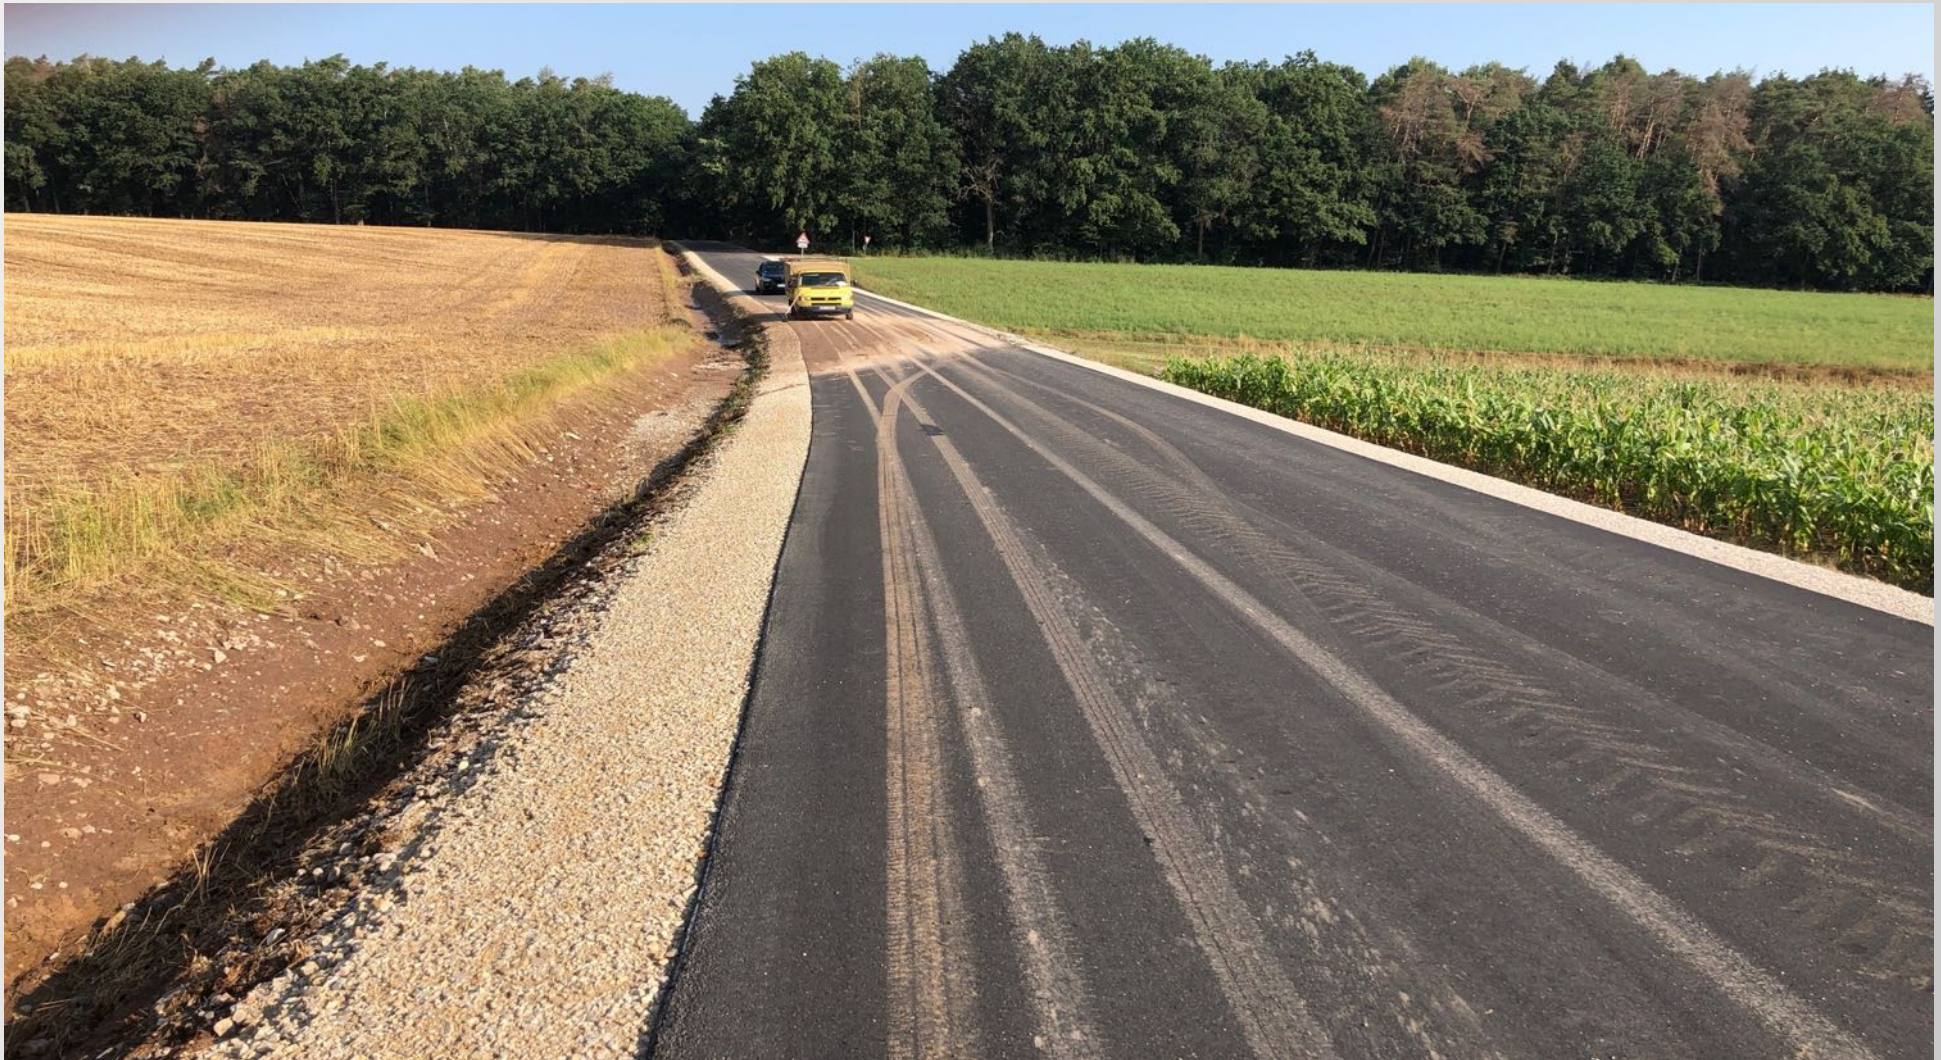
**Condition of the road after flooding due to heavy rain in August 2021**

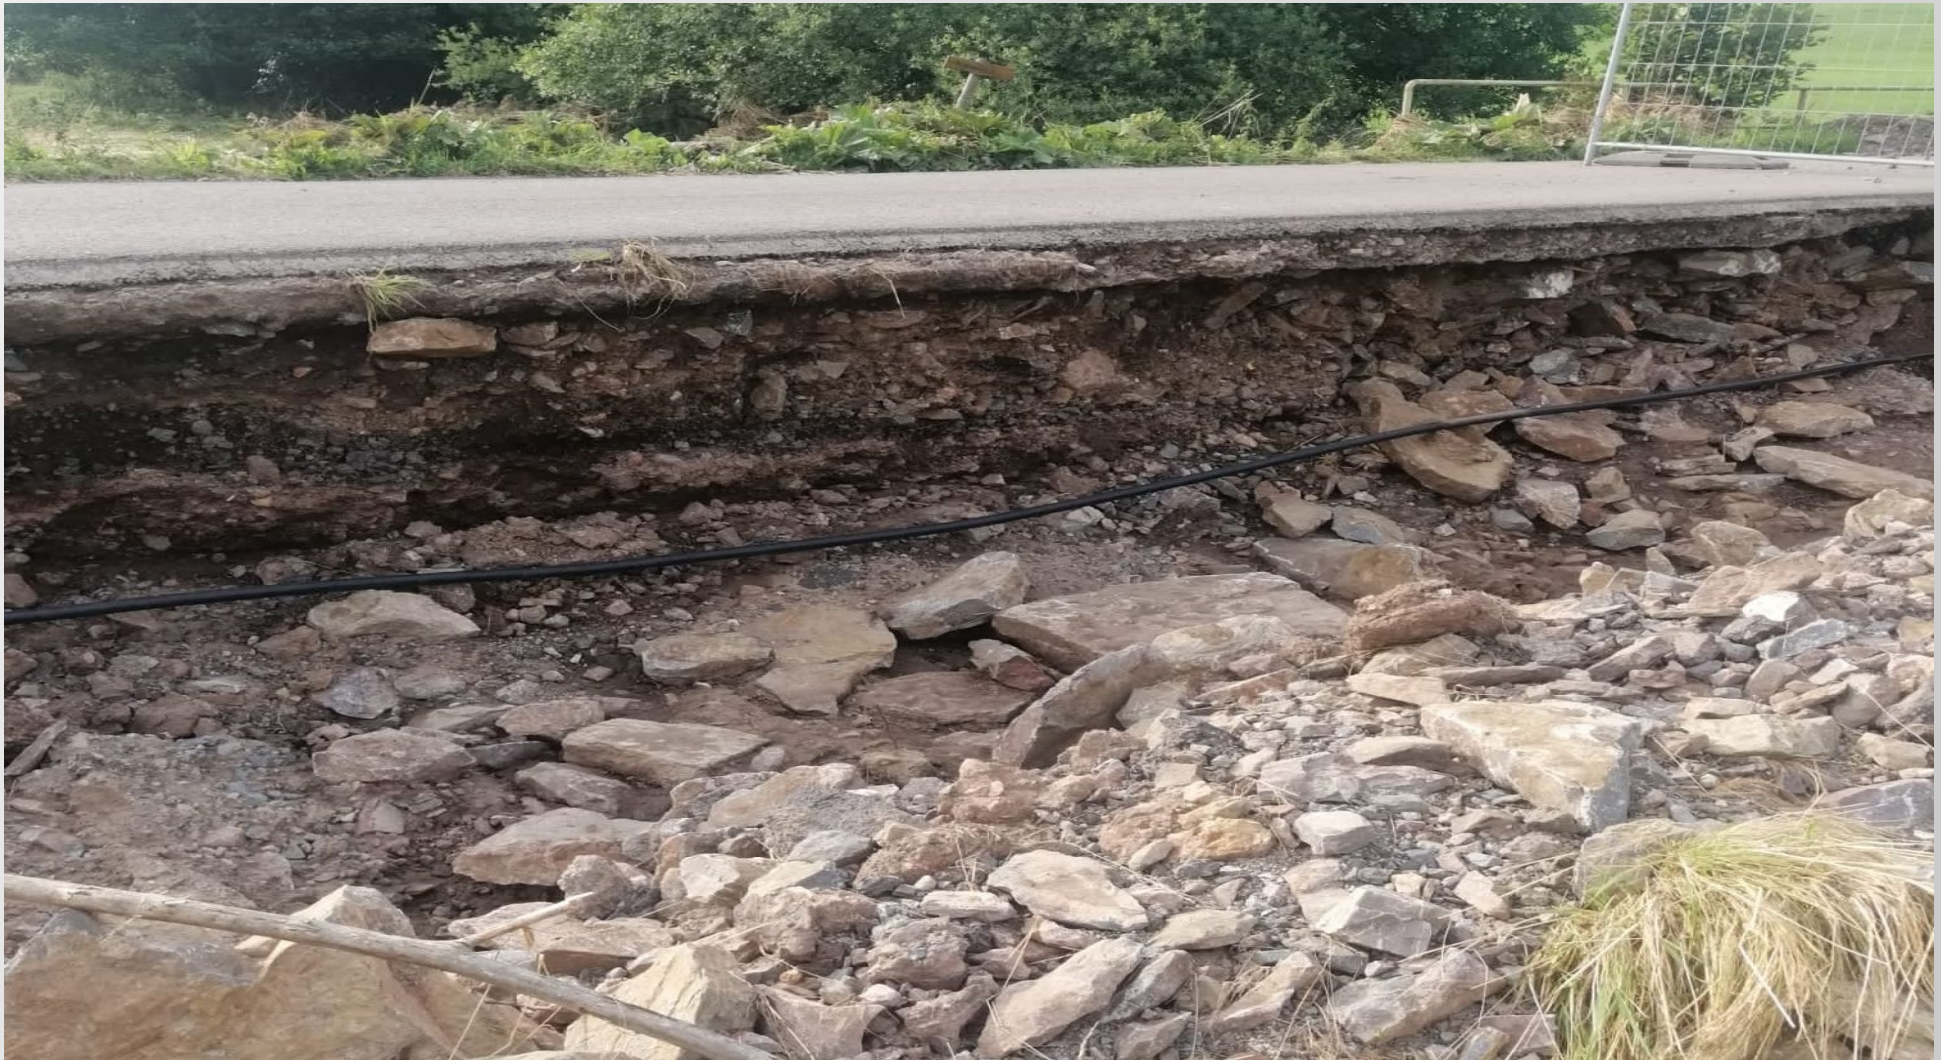
**Condition of the road after flooding due to heavy rain in August 2021**

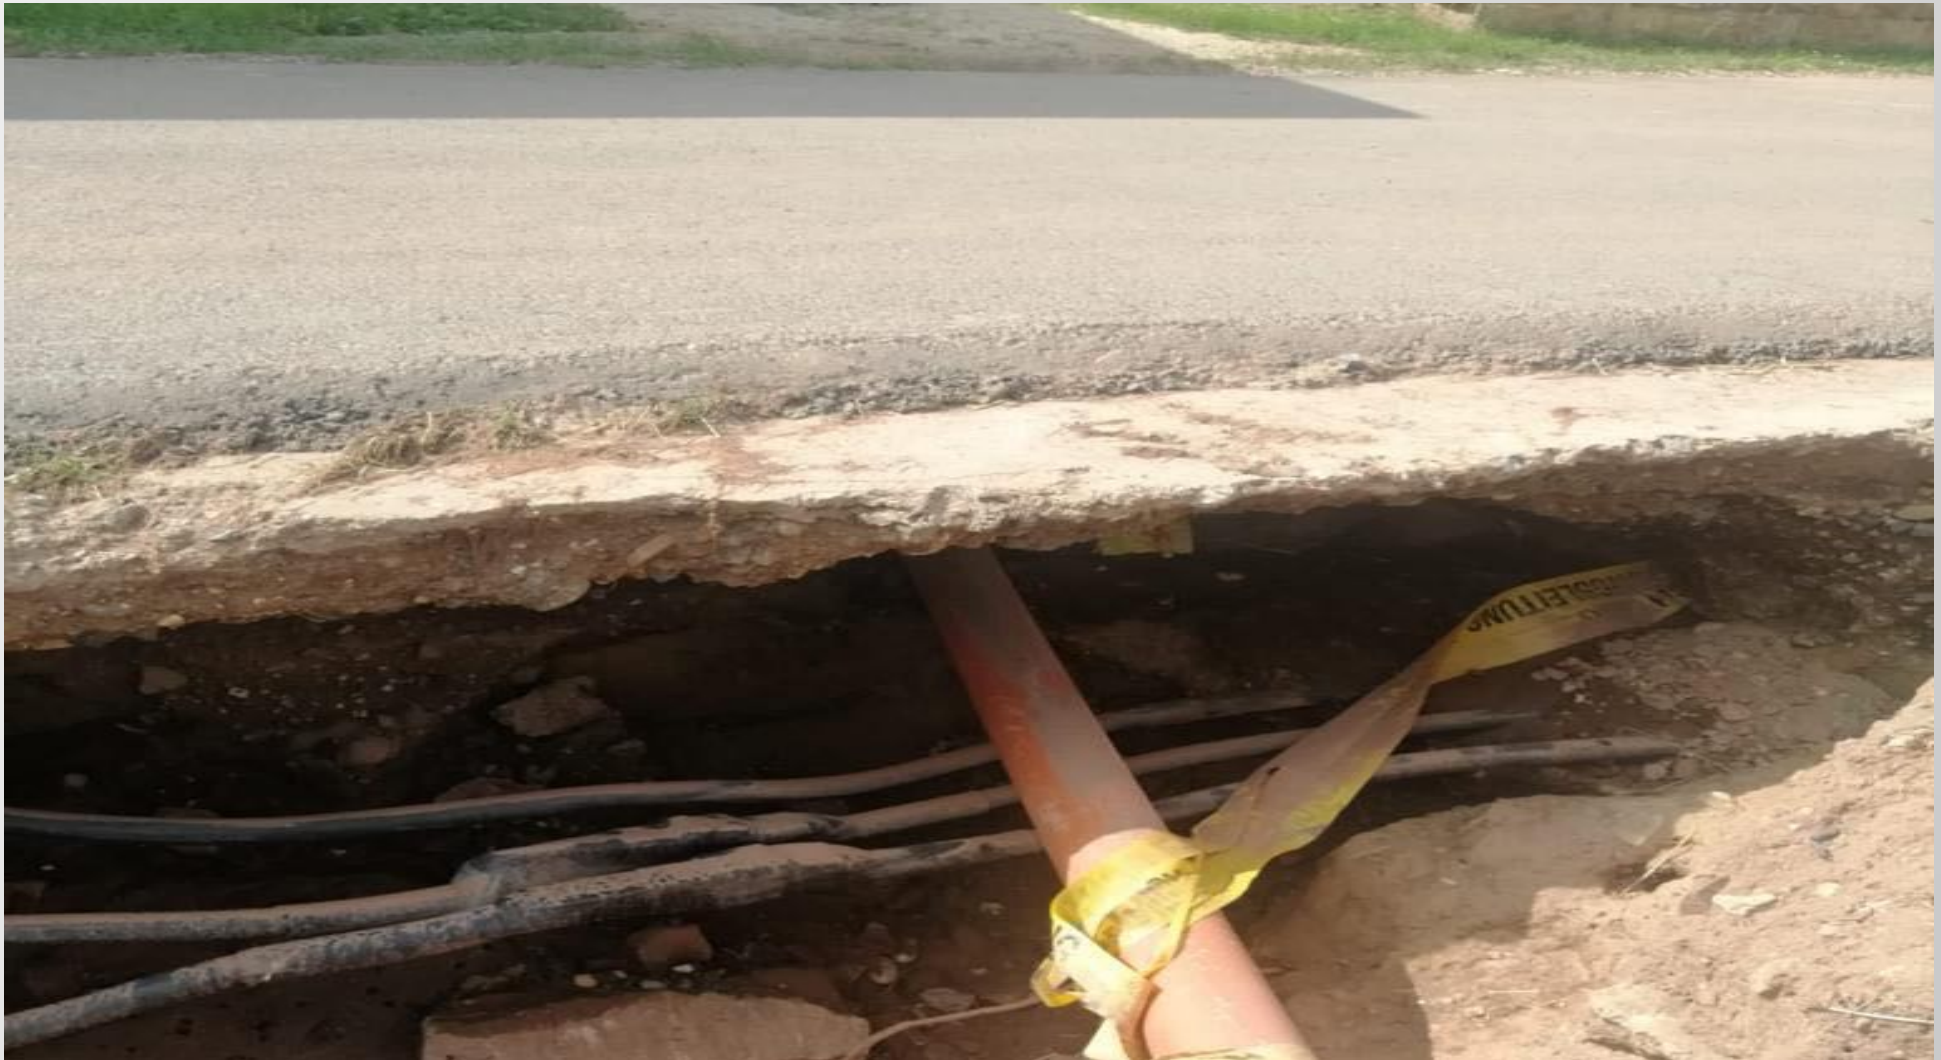
**Condition of the road after flooding due to heavy rain in August 2021**
